**VILLAGE OF CAROLINE
CAPITAL INFRASTRUCTURE PLAN**

Prepared for:
The Village of Caroline

Prepared by:
Stantec Consulting Ltd.
600, 4808 Ross St.
Red Deer, AB T4N 1X5

September 2009
113929151-07

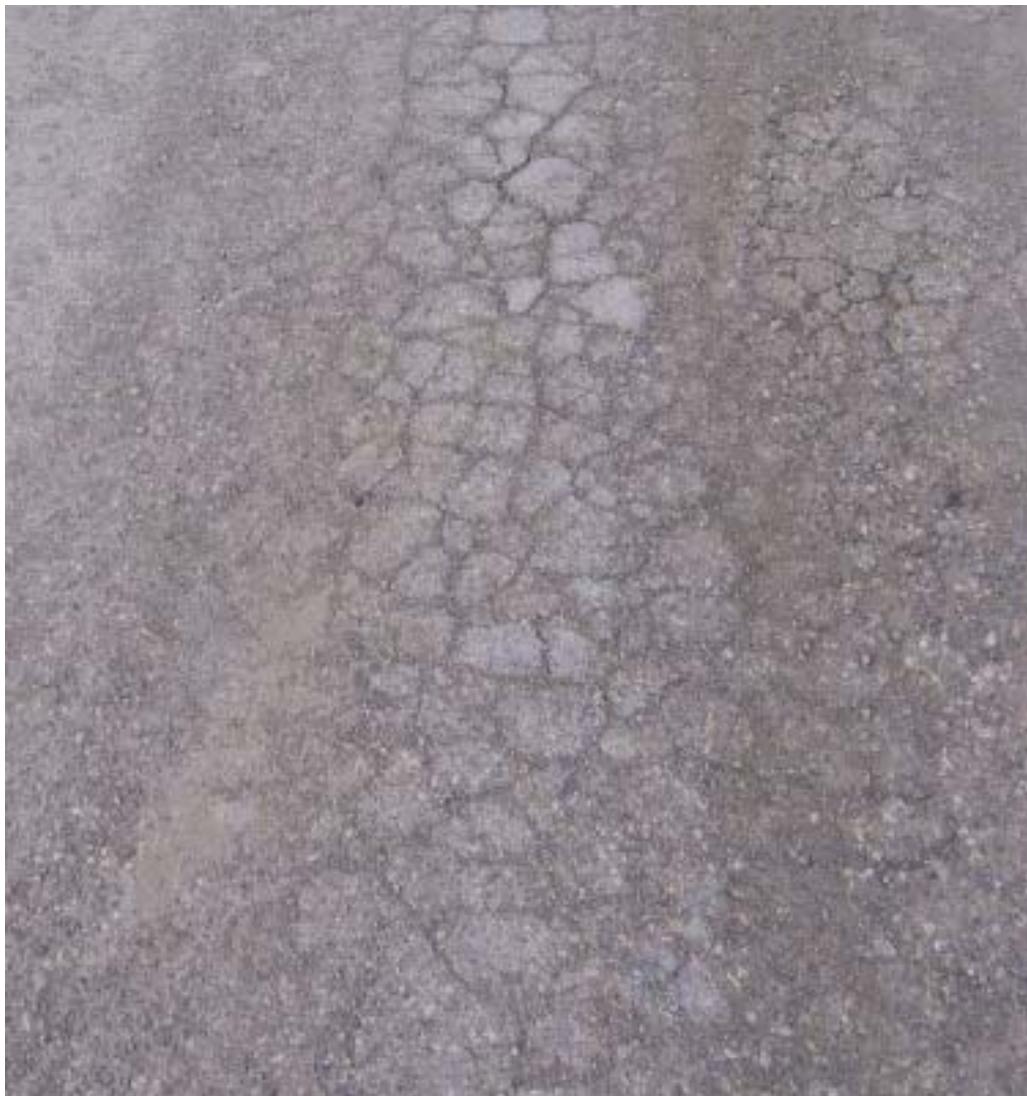
Fatigue Cracking

Occurs in areas subjected to repeated traffic loadings and can be a series of smaller interconnected cracks in early stages development which further develop into many sided pieces usually less than 0.3 metres on the longest side. In later stages chicken wire/alligator patter cracking is generally apparent. In extreme cases of fatigue cracking individual pieces of asphalt may move when subjected to traffic loading. The photo below is an example of moderate to severe fatigue cracking.

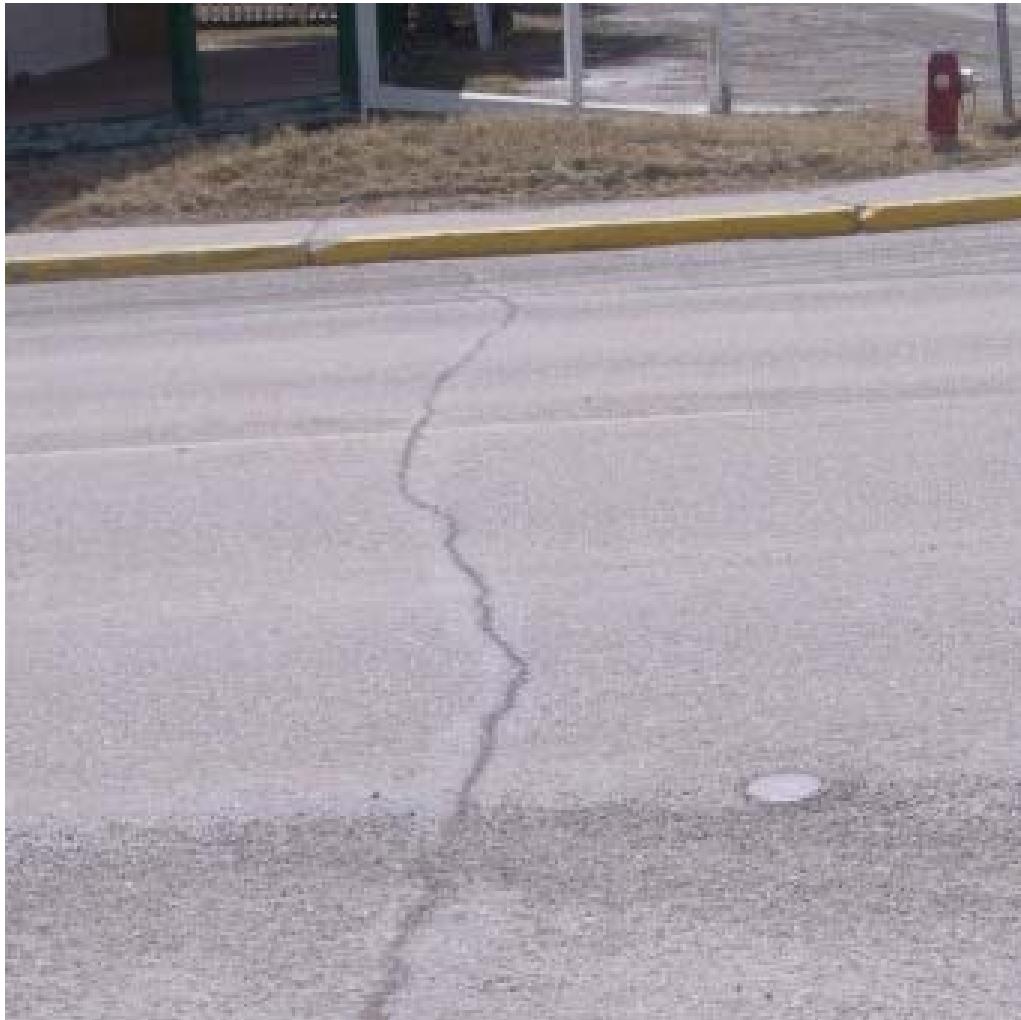
Transverse Cracking

Cracks that are predominantly perpendicular to the centerline of the roadway. The photo below is an example of moderate transverse cracking.

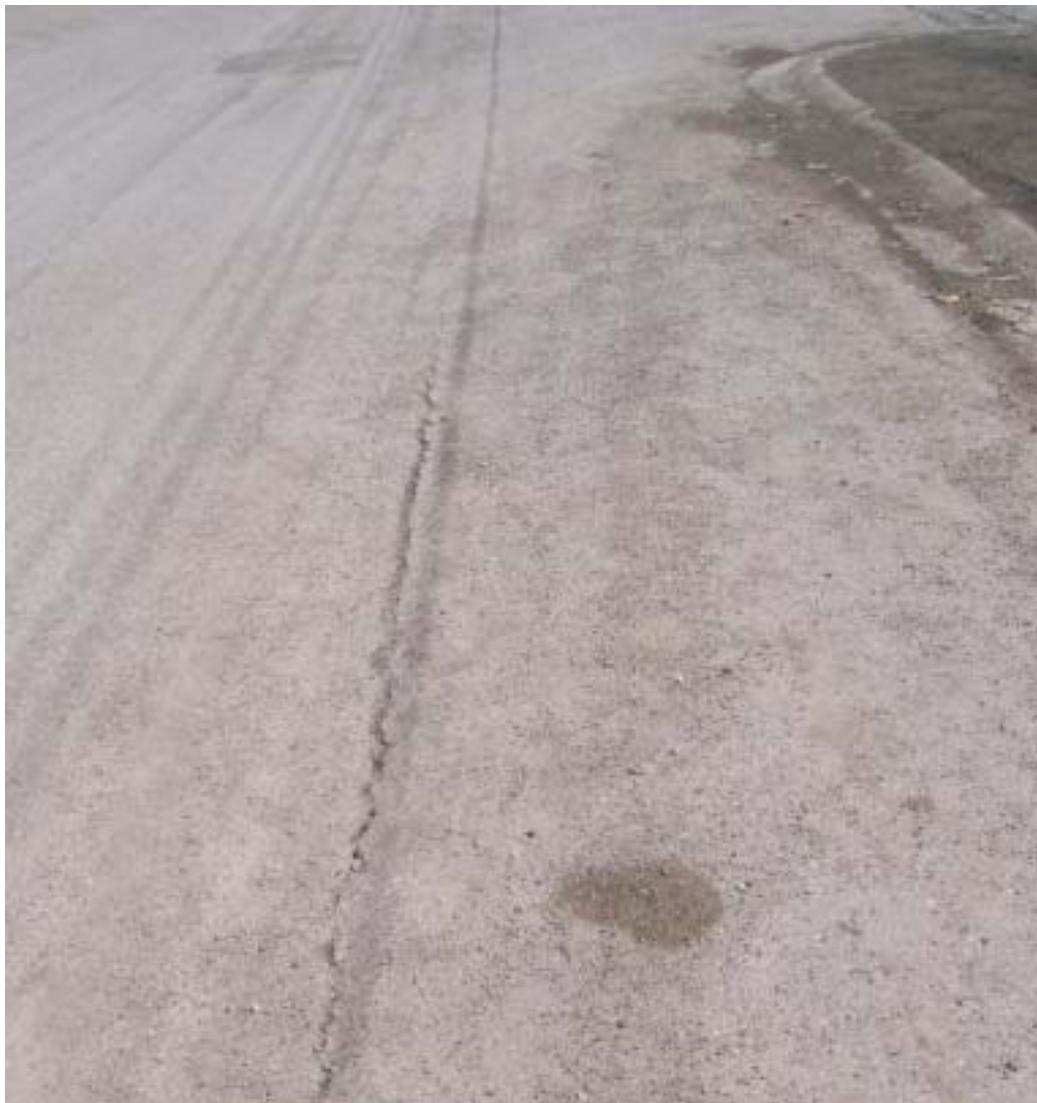
Longitudinal Cracking

Cracks that are predominantly parallel to the roadway centre line. The photo below is an example of moderate longitudinal cracking.

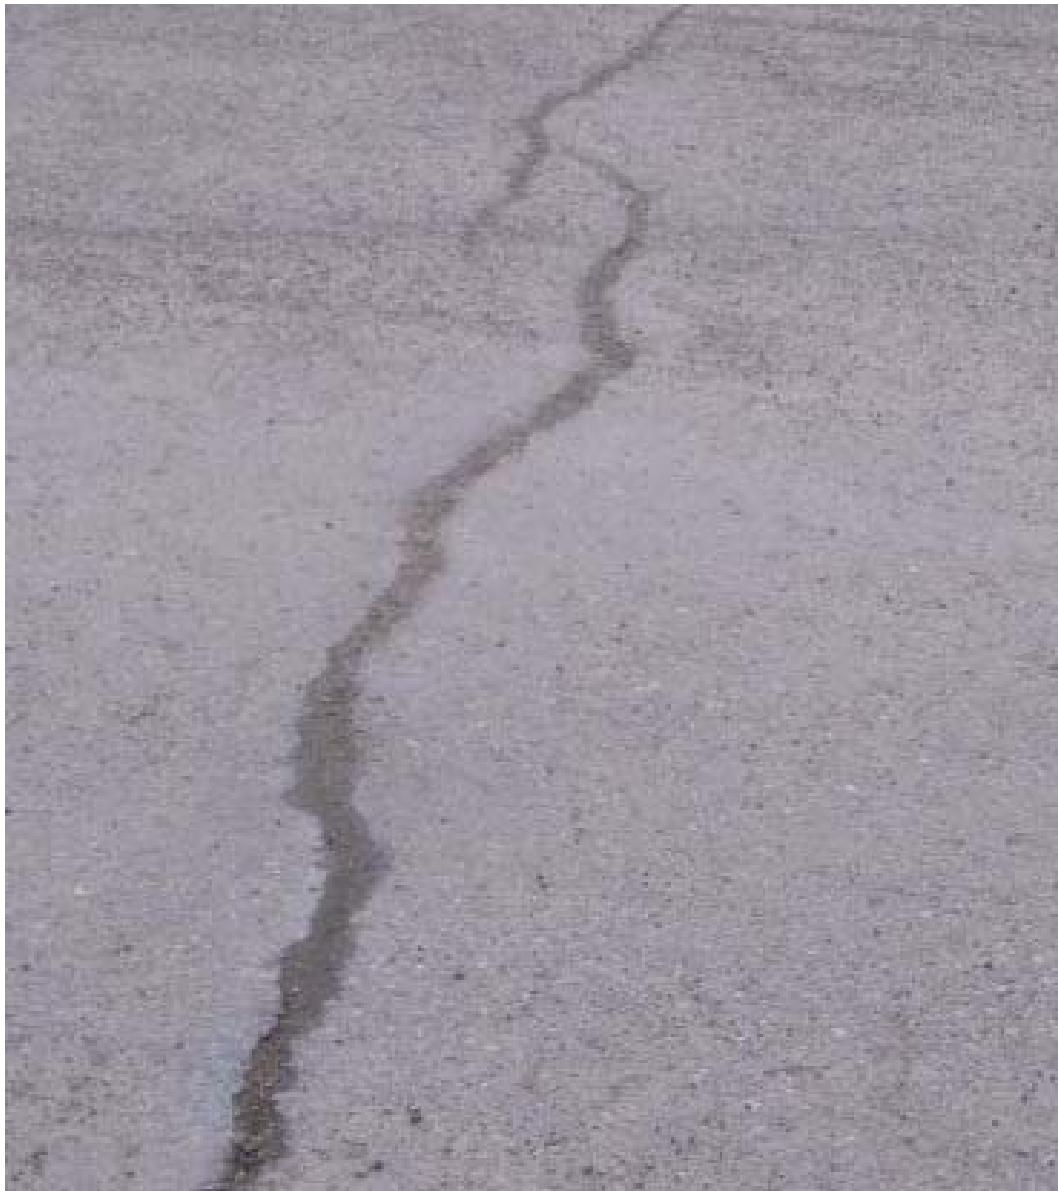
Pumping (Water Bleeding)

Seeping or ejection of water from beneath the pavement through cracks. In some cases, detectable by deposits of fine material residue on the pavement surface where were eroded (pumped) from the granular support structure of the roadway onto the surface. The photo below is an example of moderate pumping.

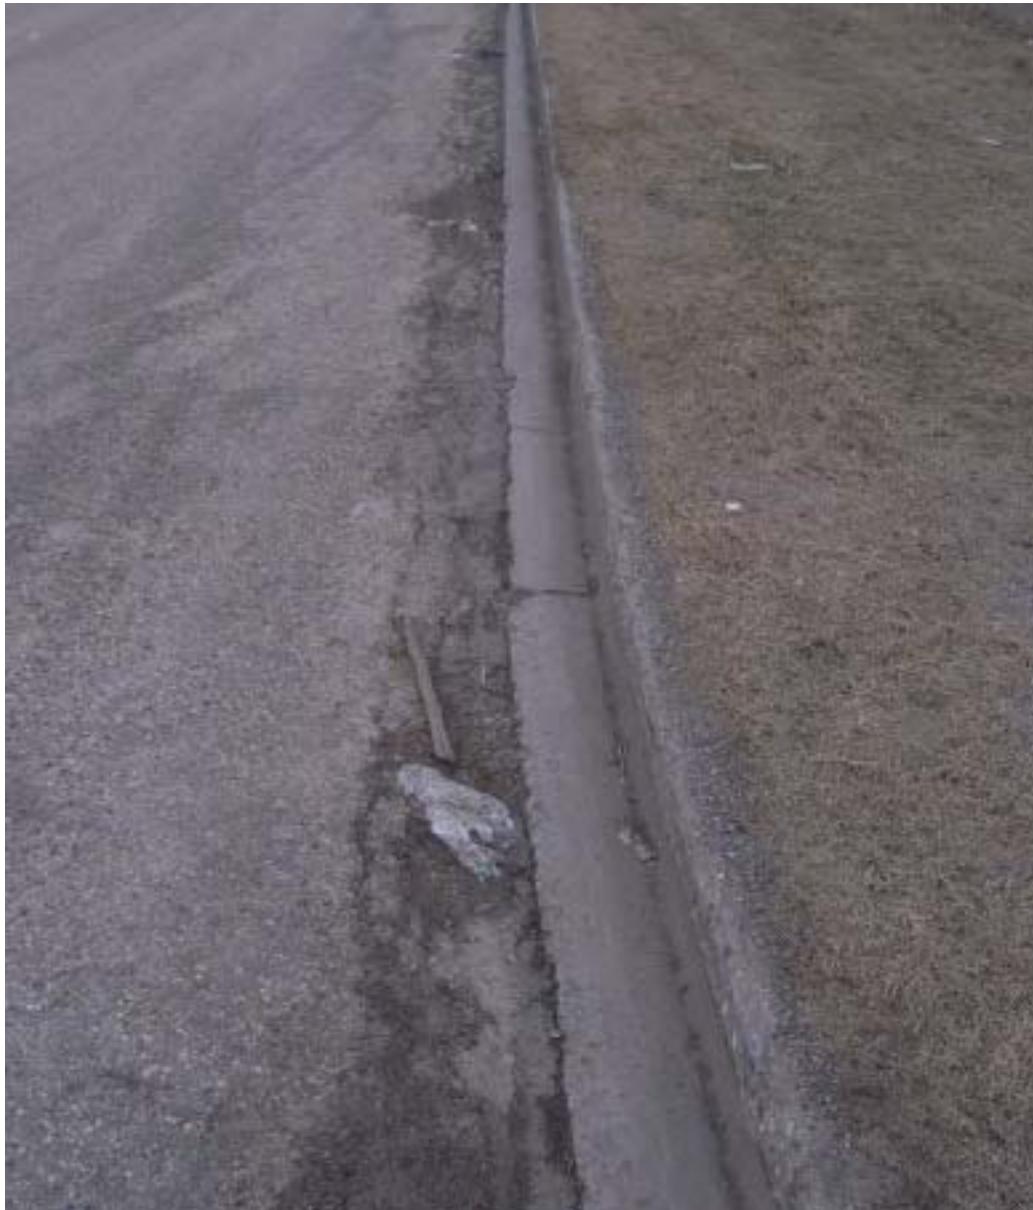
Edge Deterioration

Applies to areas typically within 0.6 metres of the pavement edge. This type of distresses is typically found in locations where on street parking lanes have been provided. The photo below is an example of moderate to severe edge deterioration.

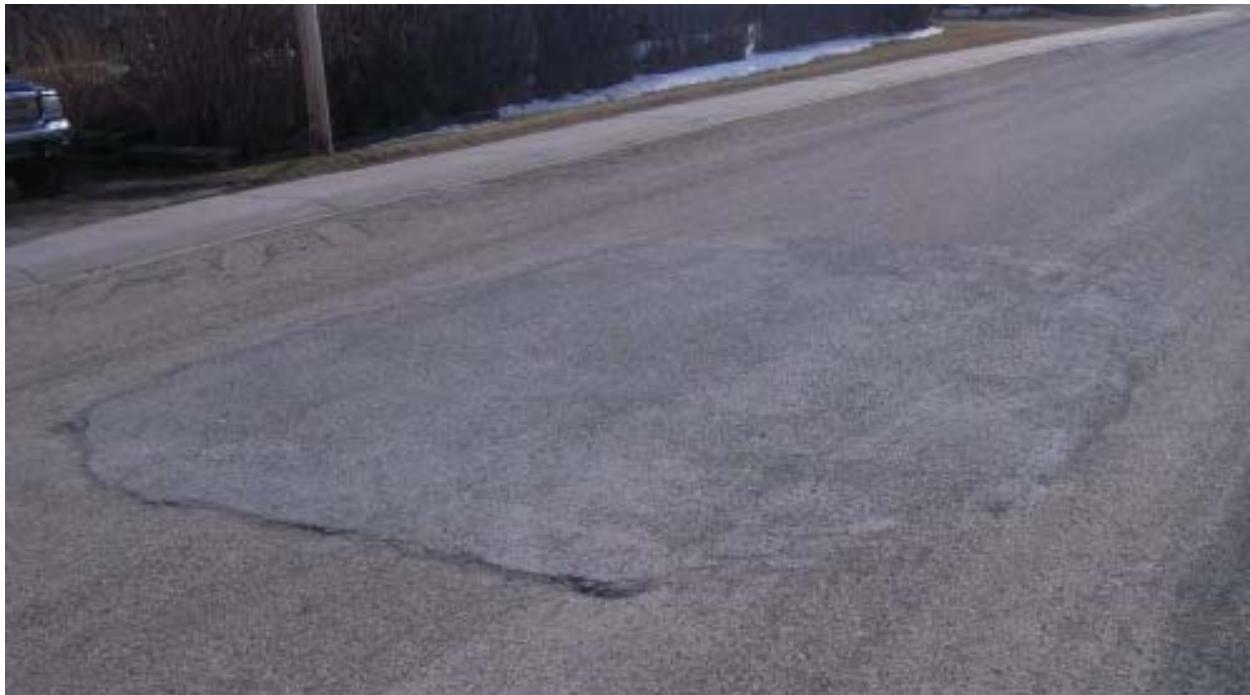
Patching & Patch Deterioration

Portions of the pavement surface, greater than 0.1 square metres that have been removed and replaced or additional material applied after the original construction. The photo below is an example of patching with minor deterioration.

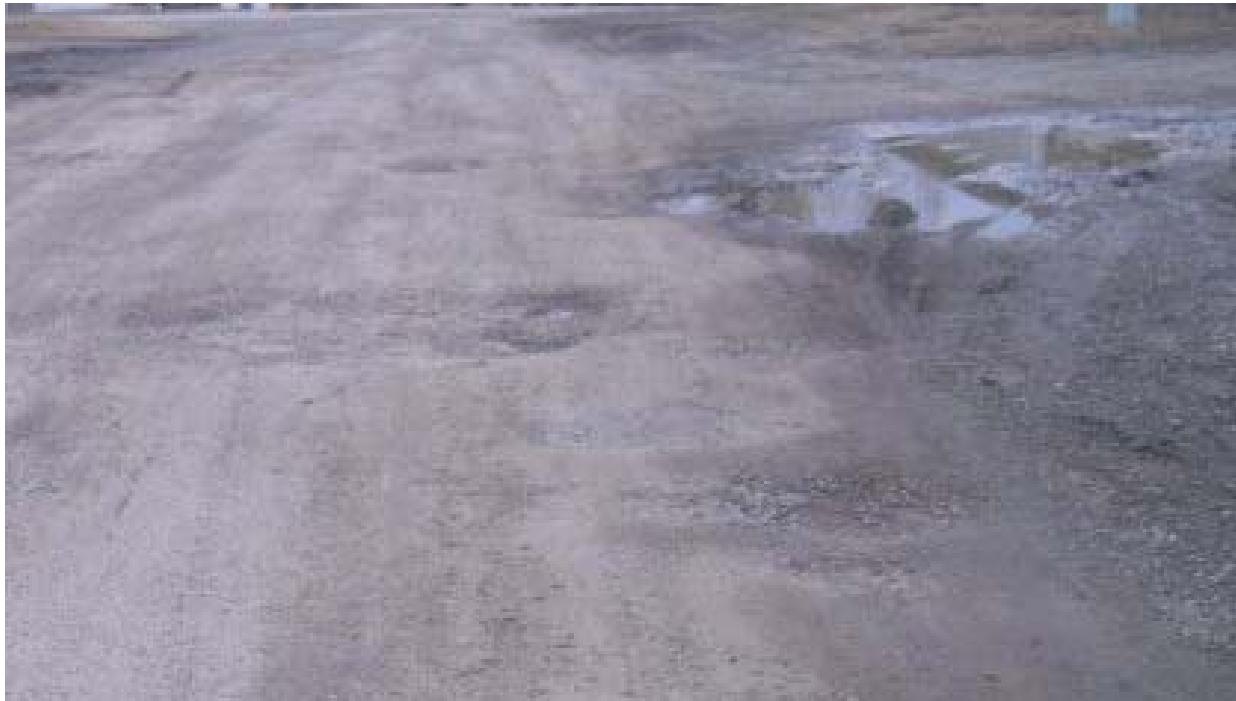
Potholes

Bowl-shaped holes of various sizes in the surface, often resulting in standing water and water infiltration into the base of the road structure. The photo below is an example of a roadway with many moderate to severe potholes where the roadway surface is heavily deteriorated.

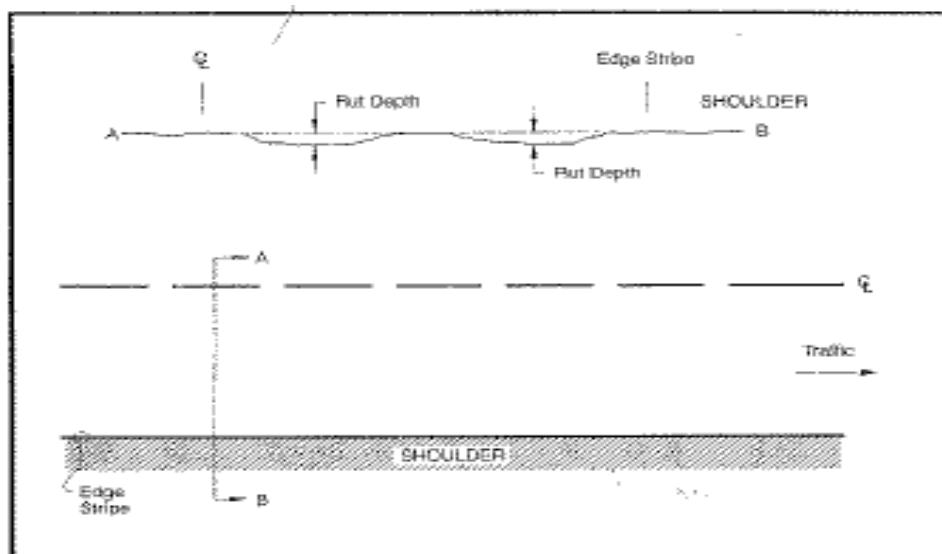
Rutting

A rut is a longitudinal surface depression in the wheel path which may have associated transverse displacements.

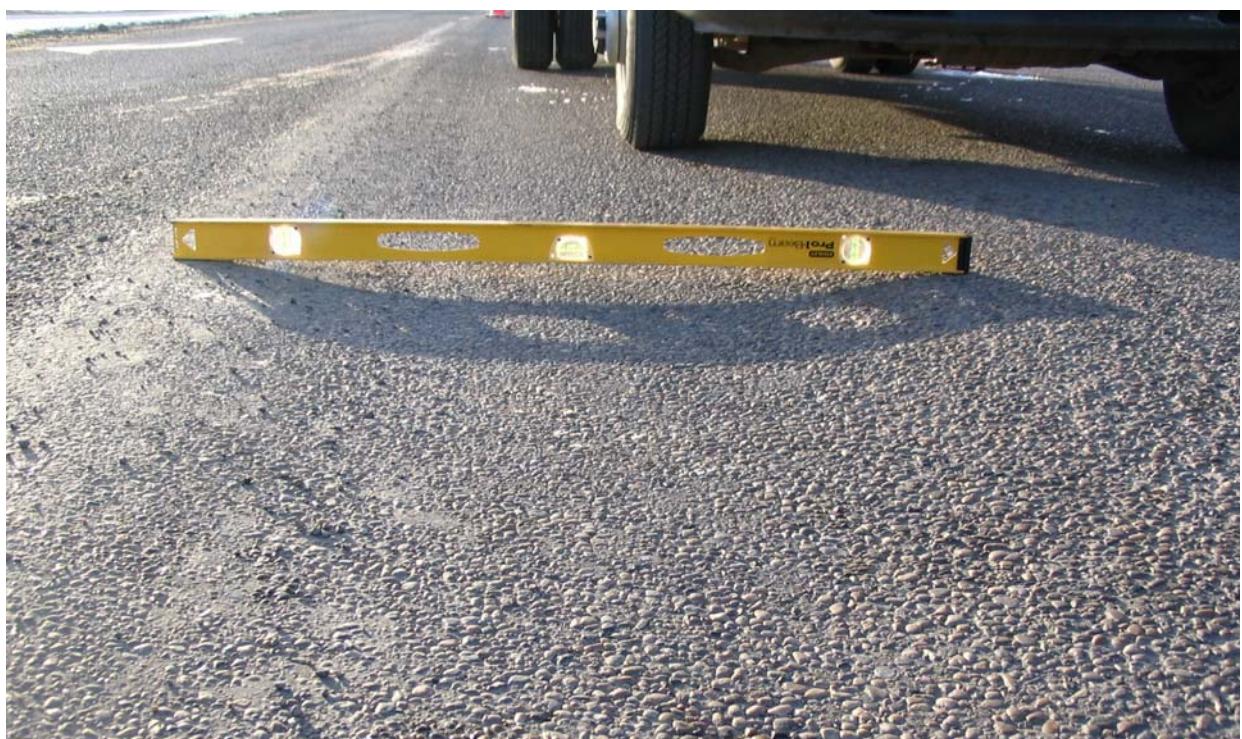
The photo below is an example of severe rutting.

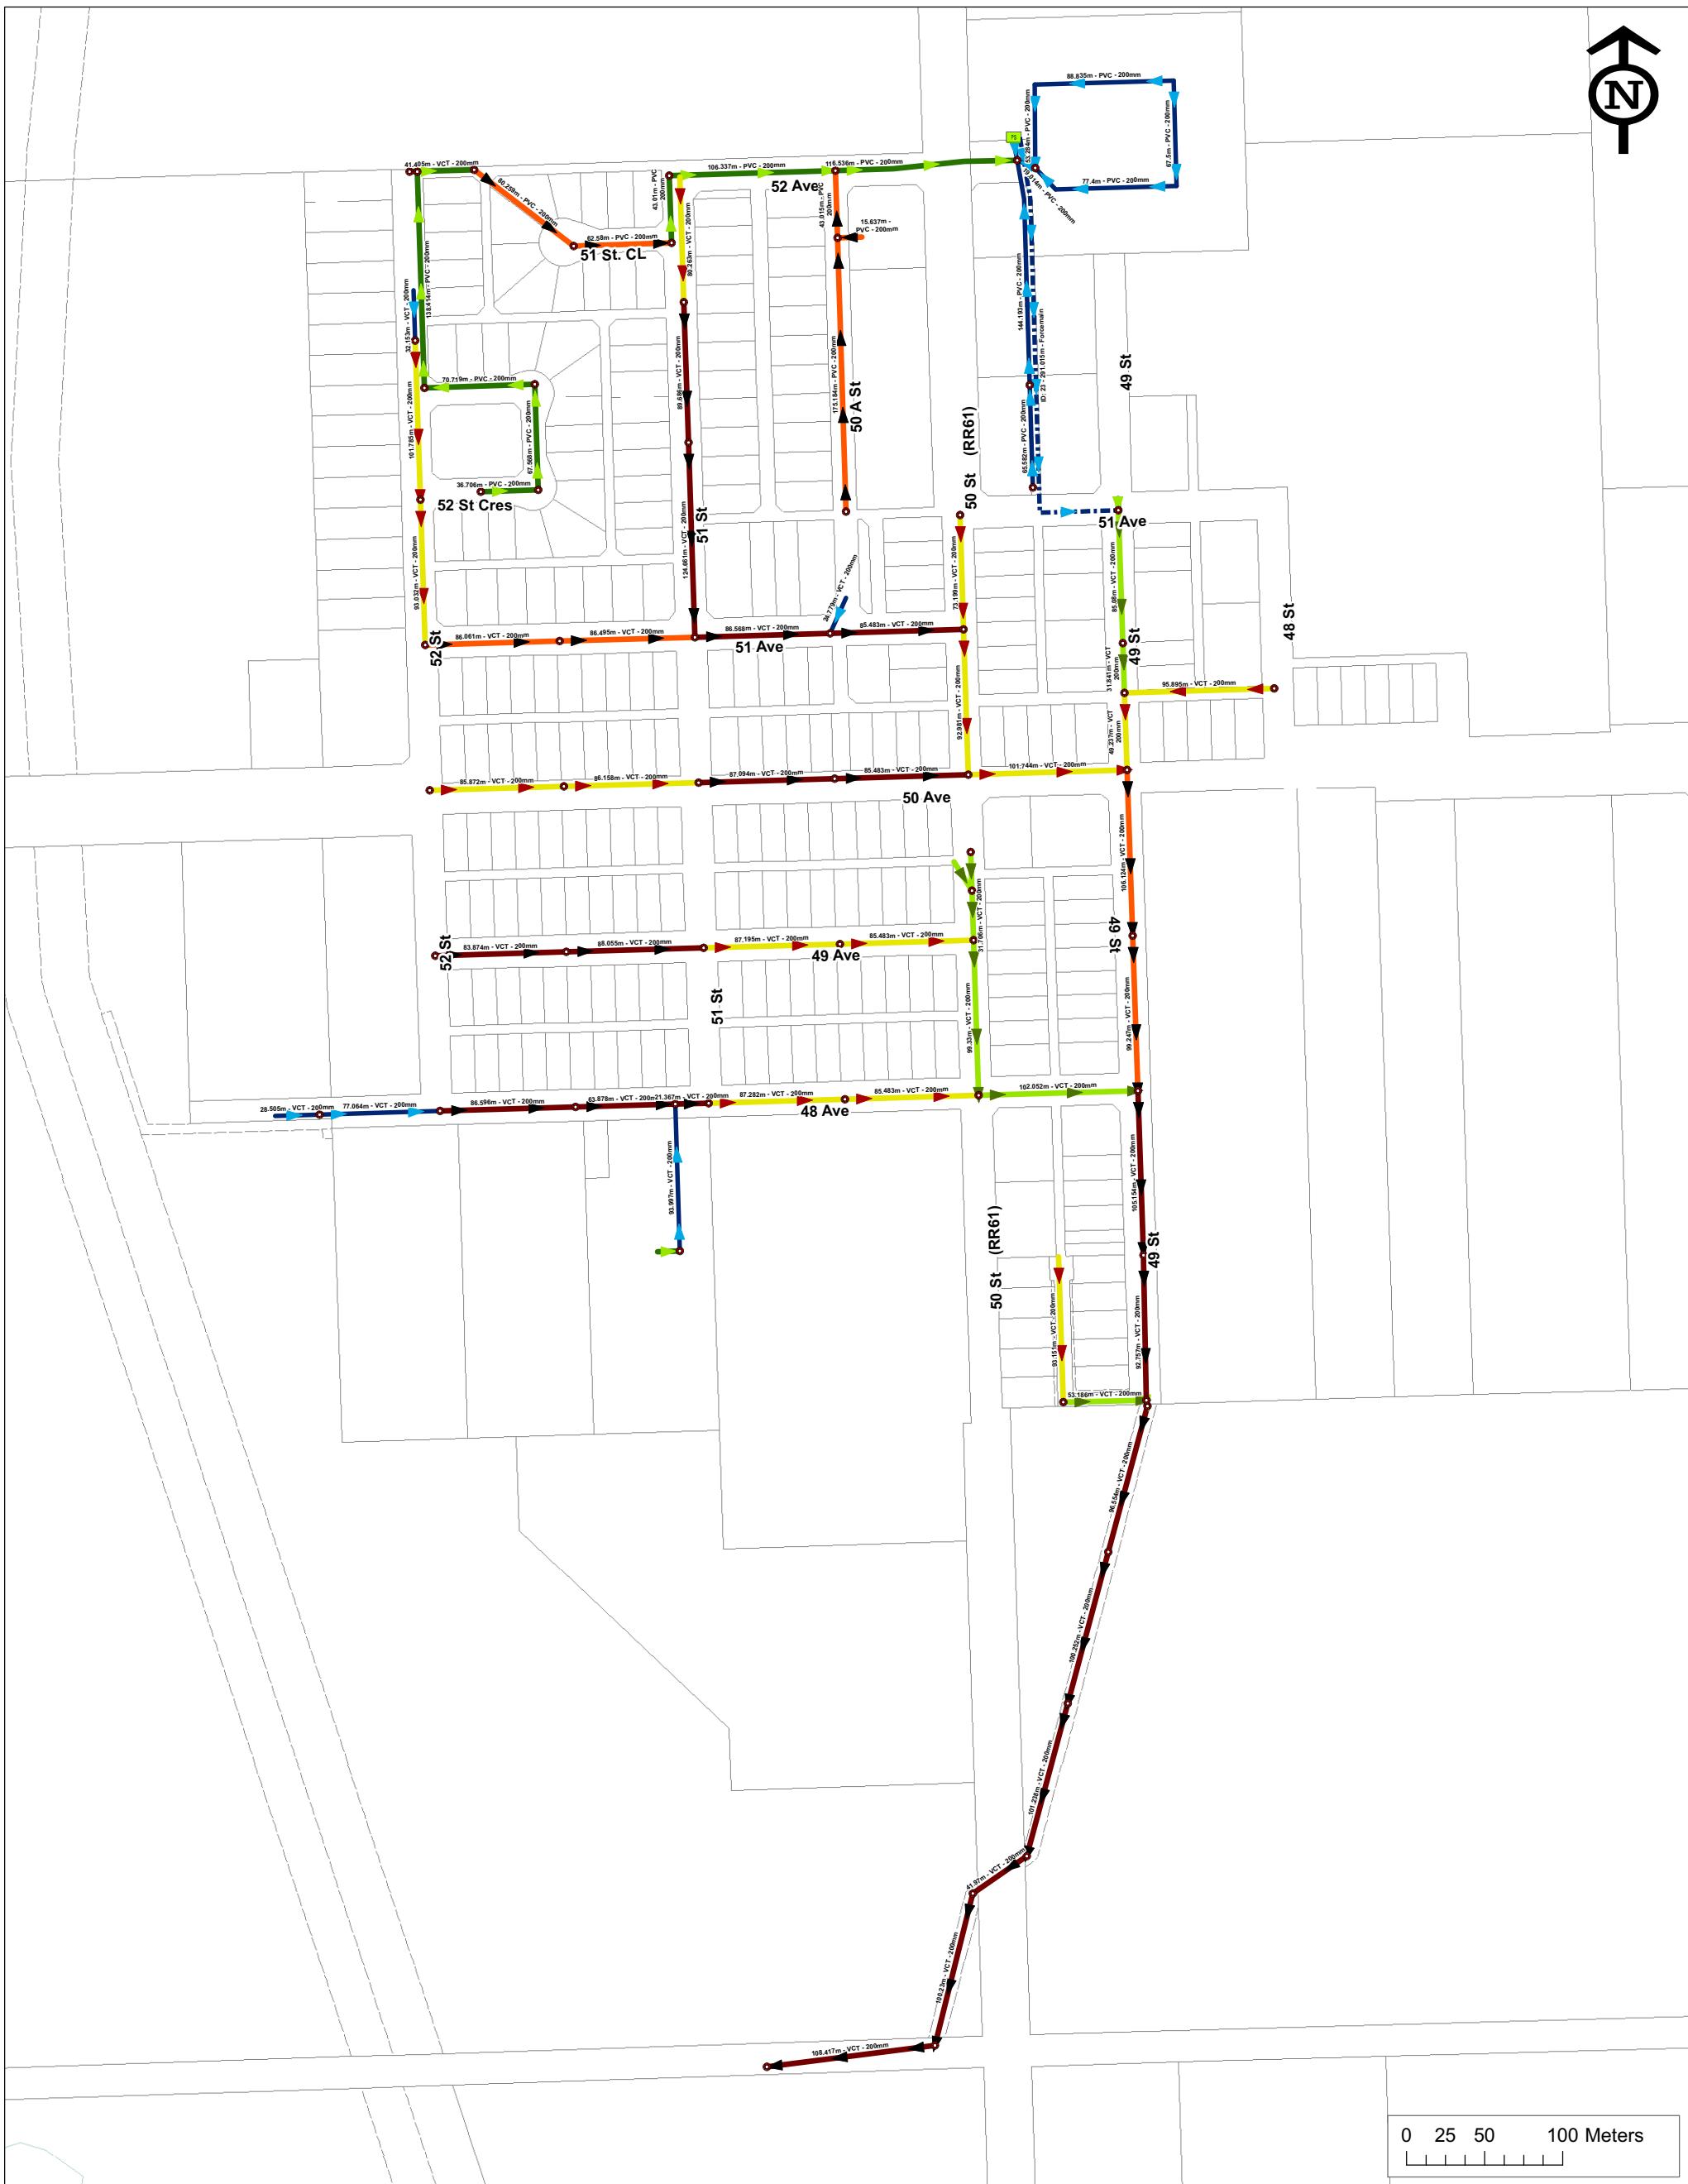
VILLAGE OF CAROLINE: SANITARY SYSTEM

Since sections with a rating of 3 or higher pose minimal risk for the next 10 years, the report will focus on the sections with a rating of 2 or lower. These sections are outlined in Figure 3.1 of Appendix B along with a complete list of the sanitary sewer condition ratings.

The Sanitary Sewer System Drawing in Appendix B outlines the sanitary sewer conditions. The approximated construction costs for the sanitary sewer replacement are based on the schedule provided in Appendix B. Where possible; sanitary sewer replacements for specific locations will be coordinated with watermain and roadway replacements.
